Tom Martin
MB Engineering Solutions,
Motherwell, UK

Iain A. MacLeod
University of Strathclyde,
UK

The Tay Rail Bridge disaster revisited

A view is being expressed that the Tay Rail Bridge disaster of 1879 was not fundamentally due to the action of the wind but was a result of fatigue damage caused by dynamic loading. The paper discusses this proposition and shows that the evidence to support it is weak.

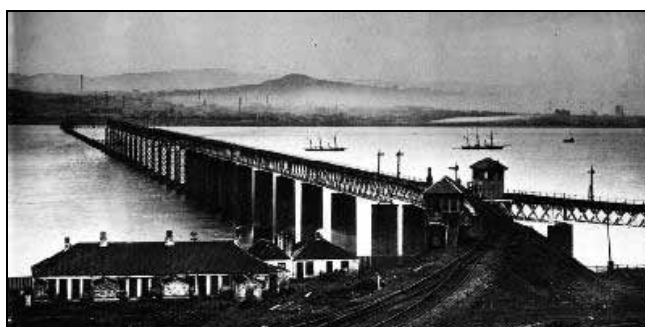
In a previous paper¹ the results of an investigation into the collapse of the ill-fated Tay Rail Bridge (Fig. 1) based on a three-dimensional analysis of one of the pier structures are described. This indicated that the trigger to the collapse was uplift of the base of the windward column causing an increase in load in the under-strength diagonal ties resulting in their failure and leading to toppling collapse.

Fig. 1. Tay Rail Bridge after the collapse, looking from the south (courtesy of the University of St. Andrews)
