DESTINED FOR DISASTER

Was the first Tay Bridge simply blown down as is popularly believed, or was there some other explanation for this dramatic and appalling tragedy? BILL DOW, retired head of the Science Department at Dundee College of Education, and a leading authority on the subject, has spent many years sifting through the evidence, some of which was not revealed at the Inquiry. Here he explains his theory about the circumstances which caused the collapse.

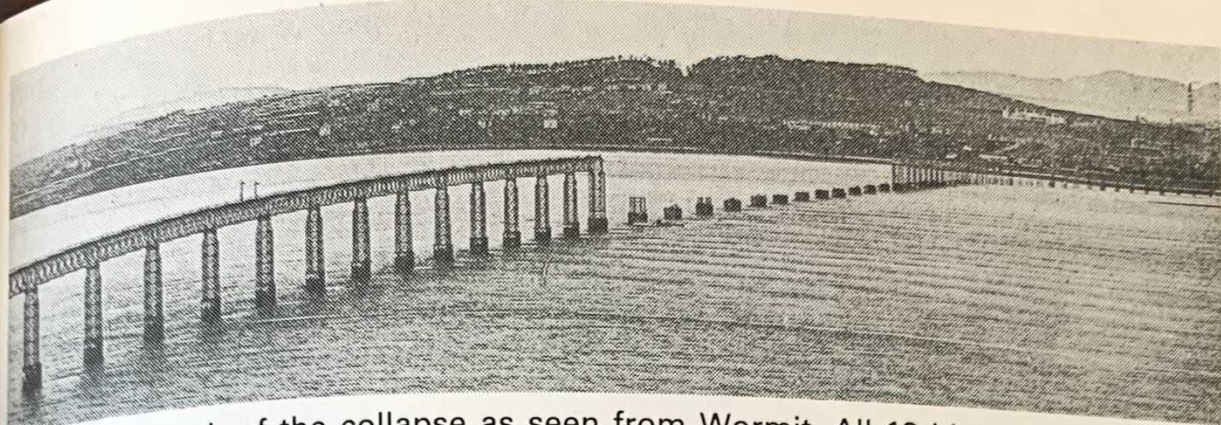
The aftermath of the collapse as seen from Wormit. All 13 high girders were brought down, but miraculously the remainder of the bridge survived. The role in the catastrophe of one of the high navigation spans is explained in the article.

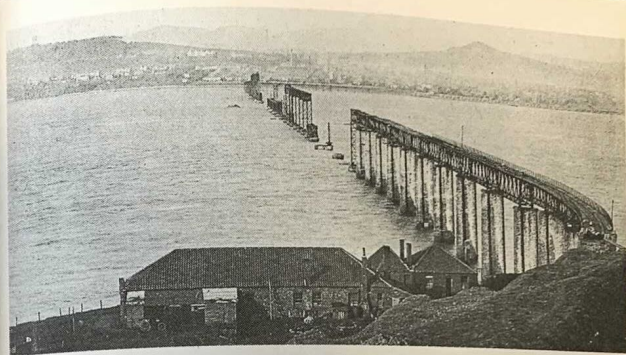
The bridge under construction in March 1877, just a month after the fall of the two high girders 28/29 and 29/30. These two spans were at the bottom of the river when this picture was taken, but 28/29 was later to be raised and put back in place. Bill Dow maintains that the use of this damaged span set in motion the events leading to the Disaster of December 1879. This is the critical scene which proves that the bridge was not built out continuously from either bank as surviving correspondence states and other historians have claimed.

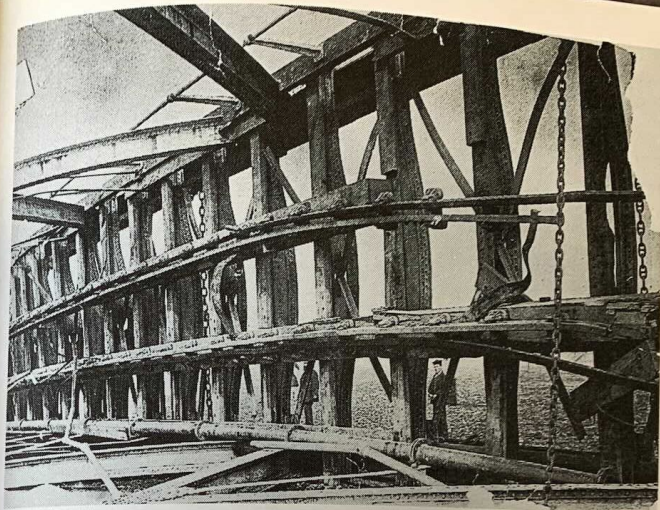
One of the high girders after recovery from the river bed. It is lying on what was its east side and this photo gives an excellent view of the girder's layout and construction. The longitudinal floor boards have all gone, but the running rails, guard rails, chairs and battens are still in place showing the manner of fixing. As can be seen, if a girder was twisted it follows that the rails would also be out of true. It is this fact that Bill Dow uses to construct his theory about the Disaster.

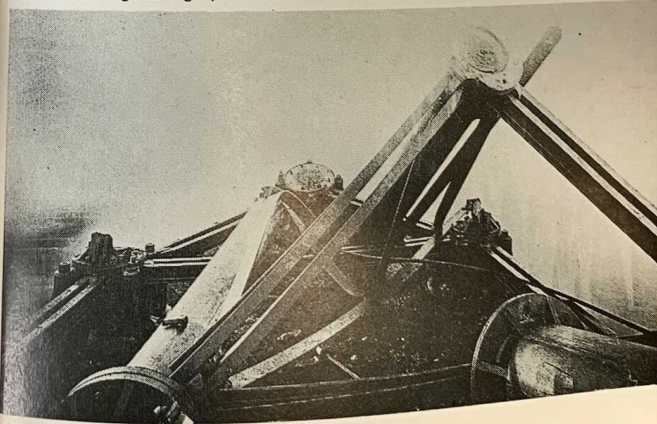
Below, looking west over one of the piers after the Disaster. The cast iron columns are broken from their flanges, but the holding down bolts which fixed the ironwork to the stone tops of the cutwaters are all intact (none of the holding down bolts gave way). At the top of the picture, an end of the wrought iron cross bracing can be seen still intact and still with a bolt through it. None of the ends of the cross bracings were broken by tension or shear. In all cases, the cast iron lugs of the columns snapped off under tension. This tangled and shattered mess gives a graphic indication of the immensity of the collapse.

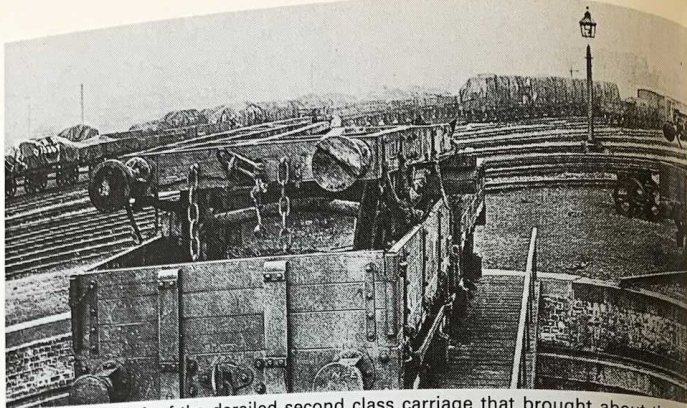
All that was left of the derailed second class carriage that brought about the bridge's downfall. The chassis is shown here on top of two wagons on the turntable at Dundee. Note the bent axle in common with all the carriage axles on the Disaster train. This damage has never been satisfactorily explained until now, but the writer believes the coaches were all thrown into the air by the whiplash action of the five joined spans immediately after their support piers gave way, and then crashed down at an angle on to the bridge decking on either their east or west wheels. It was this impact which distorted the four-inch thick steel bars that formed the axles. Note, too, the bent sole bar (side frame), distorted when the brake van telescoped into it when the triangular plate was struck.

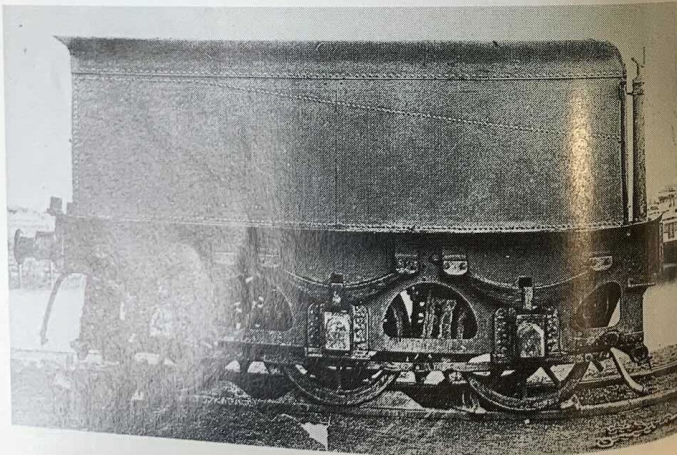
The tender of the ill-fated locomotive No. 224 at Tayport after recovery. Apart from slight bending of a buffer beam, and loss of paint by tide action, it was undamaged. Inside span 32-33 it had fallen 100 feet into the river and then through about 20 feet of water. The fact that it remained virtually unscathed while the coaches behind all suffered badly, reinforces the author's argument that it was the whiplash action of the bridge in its dying moments that brought about their destruction.
