DESTINED FOR DISASTER

Was the first Tay Bridge simply blown down as is popularly believed, or was there some other explanation for this dramatic and appalling tragedy? BILL DOW, retired head of the Science Department at Dundee College of Education, and a leading authority on the subject, has spent many years sifting through the evidence, some of which was not revealed at the Inquiry. Here he explains his theory about the circumstances which caused the collapse.

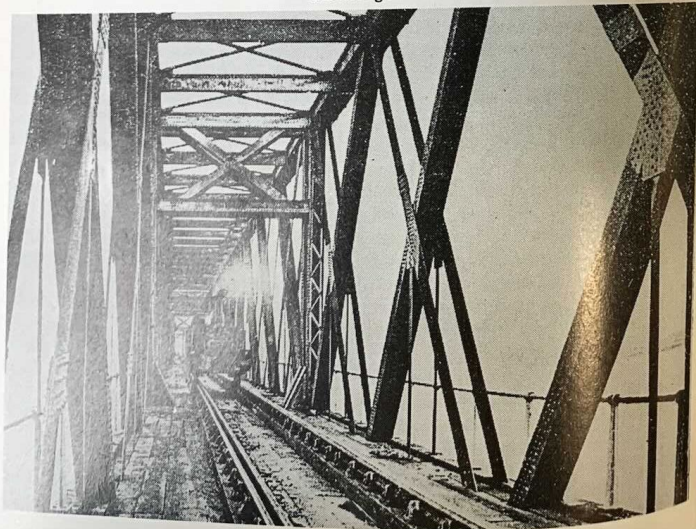
A contractor's locomotive inside one of the high girders approaching the triangular plates at the ends of each of the spans. It was this obstruction at the top of pier 32 that was to take the impact of the derailed carriage and crack the cast iron lugs of the support columns thus setting in motion the collapse of the bridge.
